**Flood Control Project Maintenance
Levee Inspections**
LMA District Cover Sheet
Spring 2009 Levee Inspection Results

Reclamation District No. 0404

Levee Inspection Report By Mile - Spring 2009

Waterway				Bank	Unit Miles	Inspection Start/End	Inspector			
Unit No. 01 San Joaquin River				Right	2.30	03/30/2009 03/30/2009	Richard Willoughby

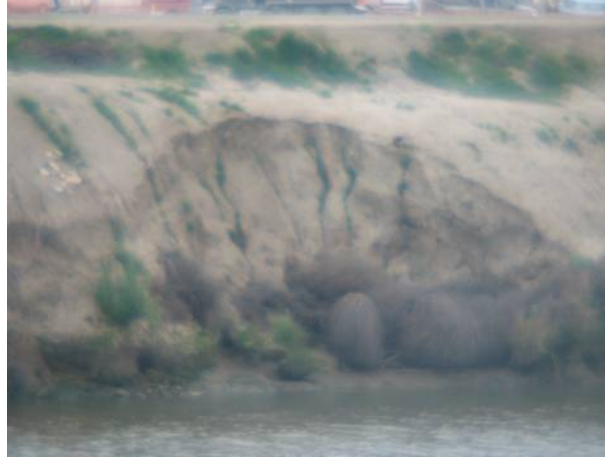
Levee Mile Report Line	4
Start Levee Mile	0.24
End Levee Mile	0.27
Location	Water Side
Category	Earthen Levee
Item	Erosion / Bank Caving
Erosion from LM 0.24 to 0.27

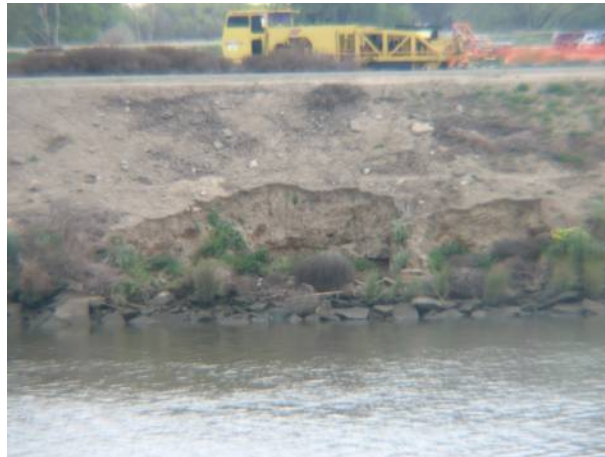
Levee Mile Report Line	4
Start Levee Mile	0.24
End Levee Mile	0.27
Location	Water Side
Category	Earthen Levee
Item	Erosion / Bank Caving
Erosion at LM 0.27

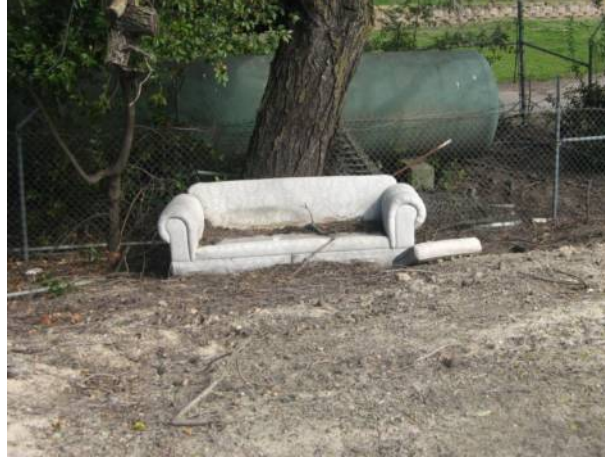
Levee Mile Report Line	8
Start Levee Mile	1.13
End Levee Mile	1.13
Location	Land Side
Category	Earthen Levee
Item	Encroachments
Sofa at landside toe LM 1.13

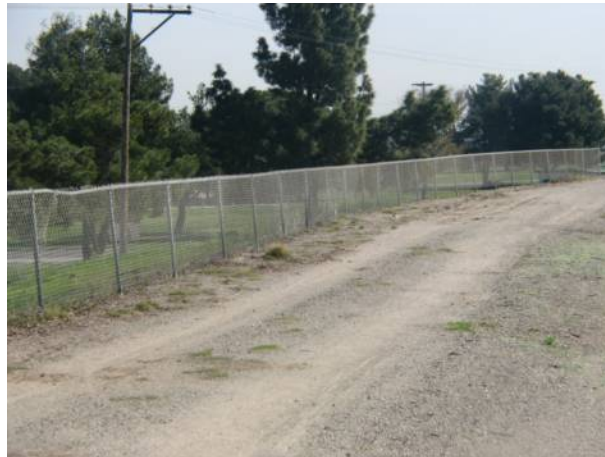
Levee Mile Report Line	11
Start Levee Mile	1.47
End Levee Mile	1.52
Location	Land Side
Category	Earthen Levee
Item	Encroachments
Fence at landside shoulder from LM 1.47 to 1.52
